WATER QUALITY M E M O R A N D U M

Utah Coal Regulatory Program

June 8, 2010

RE: 2009 Fourth Quarter Water Monitoring, Genwal Resources, Inc., Crandall Canyon Mine, Permit & Tracking #3429

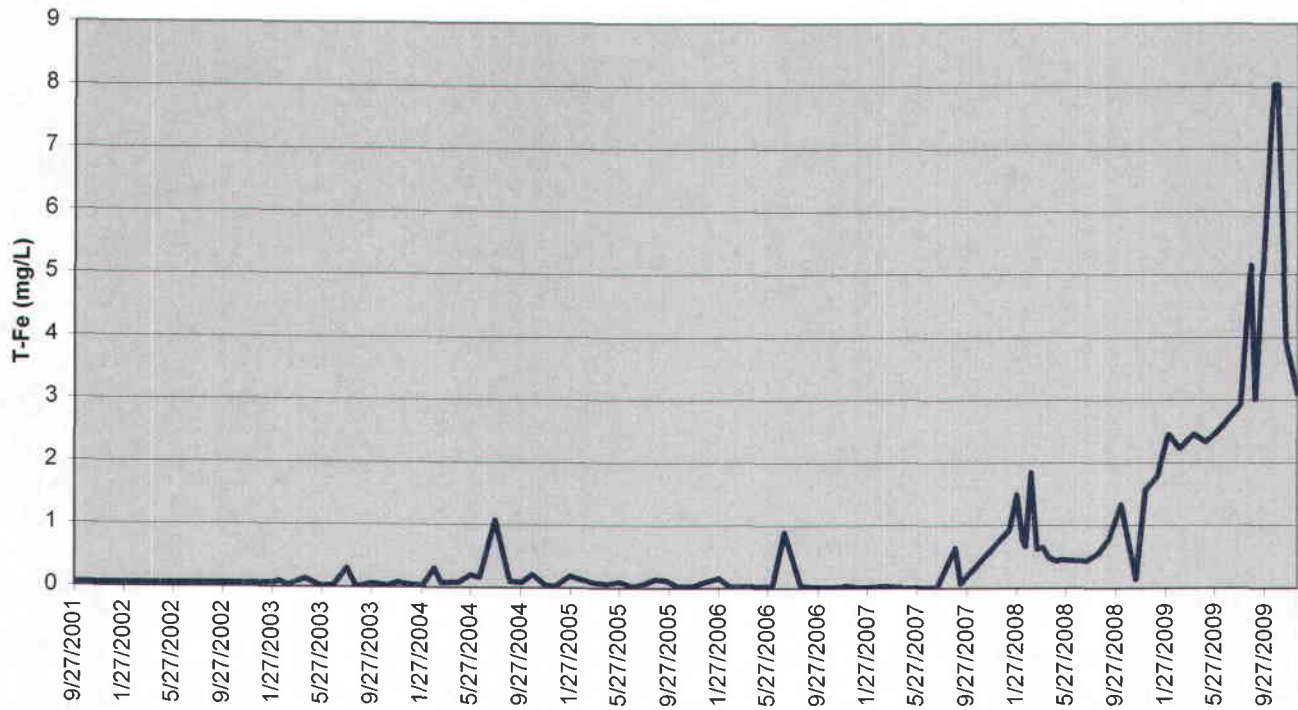
Total Iron (T-Fe): Outfall 002

Outfall 002 reported elevated T-Fe concentrations. The UPDES permit established a T-Fe limit of 1.0 ppm. All three sampling events conducted at Outfall 002 this quarter were well outside the 1.0 ppm standard (8.03 ppm, 3.927 ppm and 3.102 ppm respectively for October, November and December).

The Division is currently in the process of working with the Permittee and reviewing a proposed mine-water treatment system. Until such time as the mine-water system comes on-line and begins to effectively treat the iron discharging from the mine works, continued T-Fe concentrations above the UPDES limit will continue to be discharged into Crandall Creek.

Continued data collection and monitoring of the mine-water discharge will be necessary to evaluate the T-Fe levels within the mine-water discharge as well as the effectiveness of the mine-water treatment system once it becomes operational.

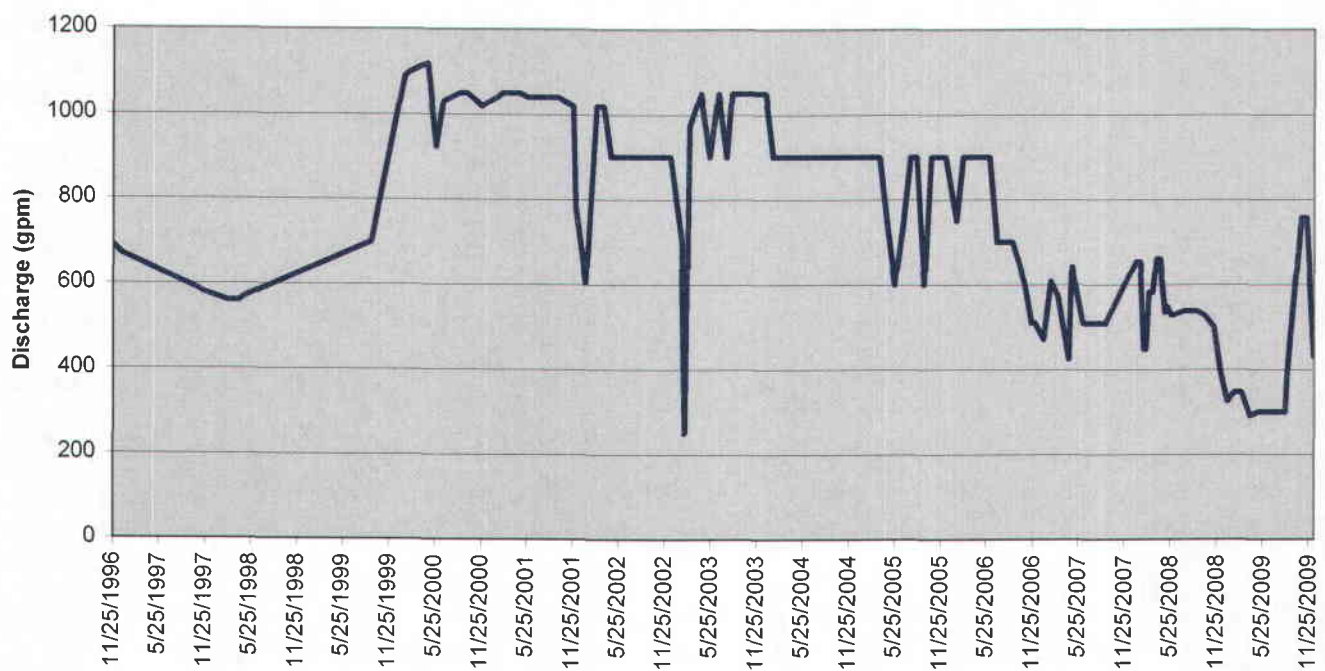
Mine Water Discharge (Outfall 002)

As noted the previous quarter, significant iron accumulations were observed within the channel of Crandall Creek. As part of the permitting process of the mine-water treatment system, the Permittee has committed to conduct a field inspection with all regulatory agencies once weather conditions allow access. The field inspection will be conducted in order to explore what (if anything) can be done to minimize the iron staining inside the channel.

Work with other regulatory agencies in determining what if anything can be done to remove or mitigate the iron staining within the Crandall Creek stream channel (See Photos Below).

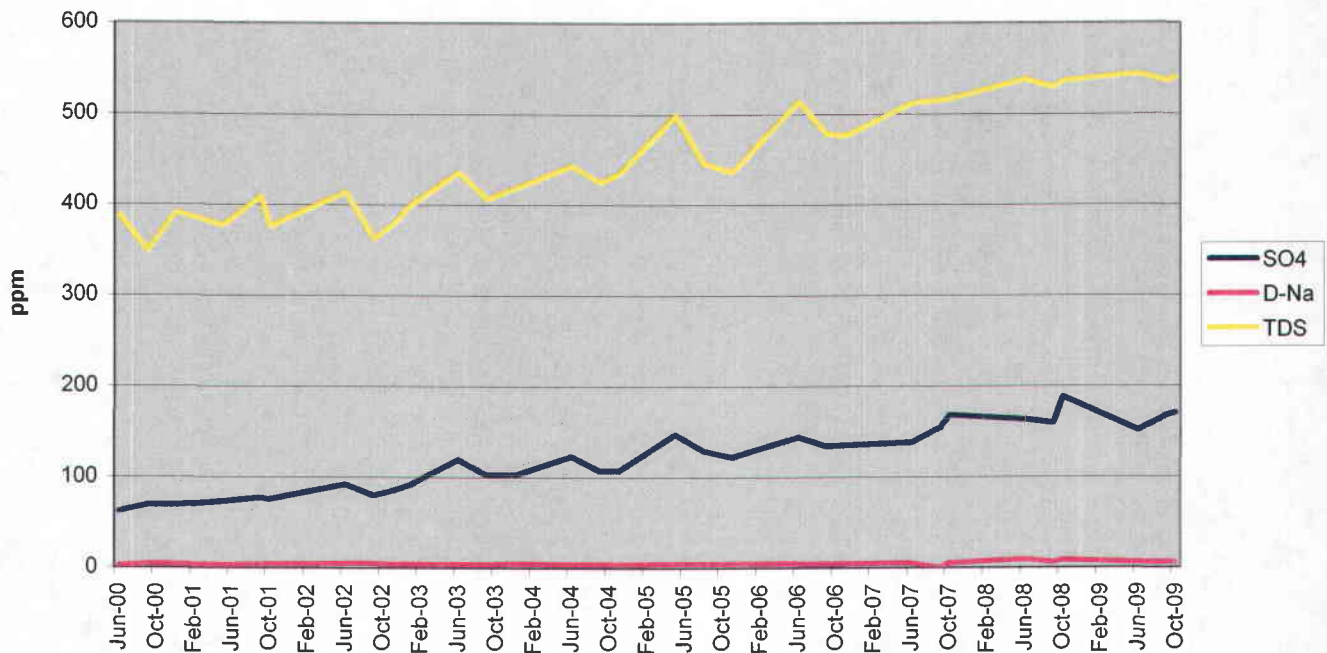
Spring SP-58 Water Quality

SP-58- Several parameters were reported outside of two standard deviations for this spring monitoring site. SO₄ was reported outside of two standard deviations for the second consecutive quarter. The mean value for SO₄ is 68.52 ppm. The reported value was 170.6 ppm.

TDS was reported outside of two standard deviations for the 3rd consecutive quarter with a reported value of 540 ppm. D-Ca and Total Hardness were also reported outside of two standard deviations of the mean.

Spring SP-58 continues to show upward trends for TDS and SO₄. Additionally, D-Ca and T-Hardns will be monitored in order to establish if an upward trend is emerging.

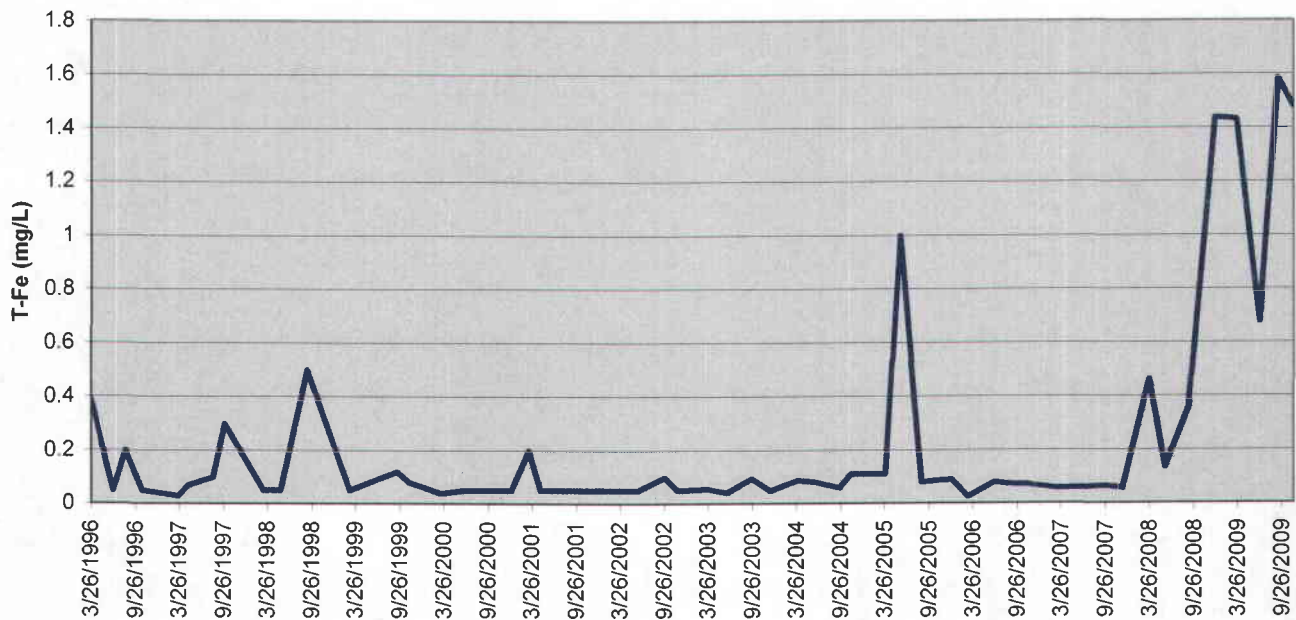
Crandall Creek Lower Flume (LOF-1): Total Iron Levels

Site LOF-1- Increasing total-iron (T-Fe) concentrations in the mine-water discharge has

produced a similar rise in total-iron below the mine site at site LOF-1 (lower Crandall Canyon flume). An upward trend of T-Fe began during the 4th quarter of 2008. The reported T-Fe concentration for this quarter was 1.479 mg/L. The elevated iron levels below the mine-site in the Crandall Canyon drainage are expected to continue until such time as the Permittee completes the construction and successfully operates the water treatment facility currently under review. The daily maximum for T-Fe, as established by the UPDES permit for the mine, is 1.0 ppm. Once the water treatment facility comes on-line and reduces the iron levels in the mine-water discharge, it follows that a significant drop in T-Fe concentrations within the Crandall Creek drainage would be expected. Continuing monitoring will determine the effectiveness of the proposed water treatment system.

Continue to monitor water quality conditions downstream of the mine-site (specifically site LOF-1). T-Fe levels within the Crandall Creek drainage have been trending upward as a result of the mine-water discharge.
